**RADIOLOGICAL CHARACTERIZATION REPORT FOR
FUSRAP PROPERTIES IN THE ST. LOUIS, MISSOURI, AREA**

VOLUME I

MARCH 1990

**K. C. Noey
C. M. Sekula
Bechtel National, Inc.
Oak Ridge, Tennessee**

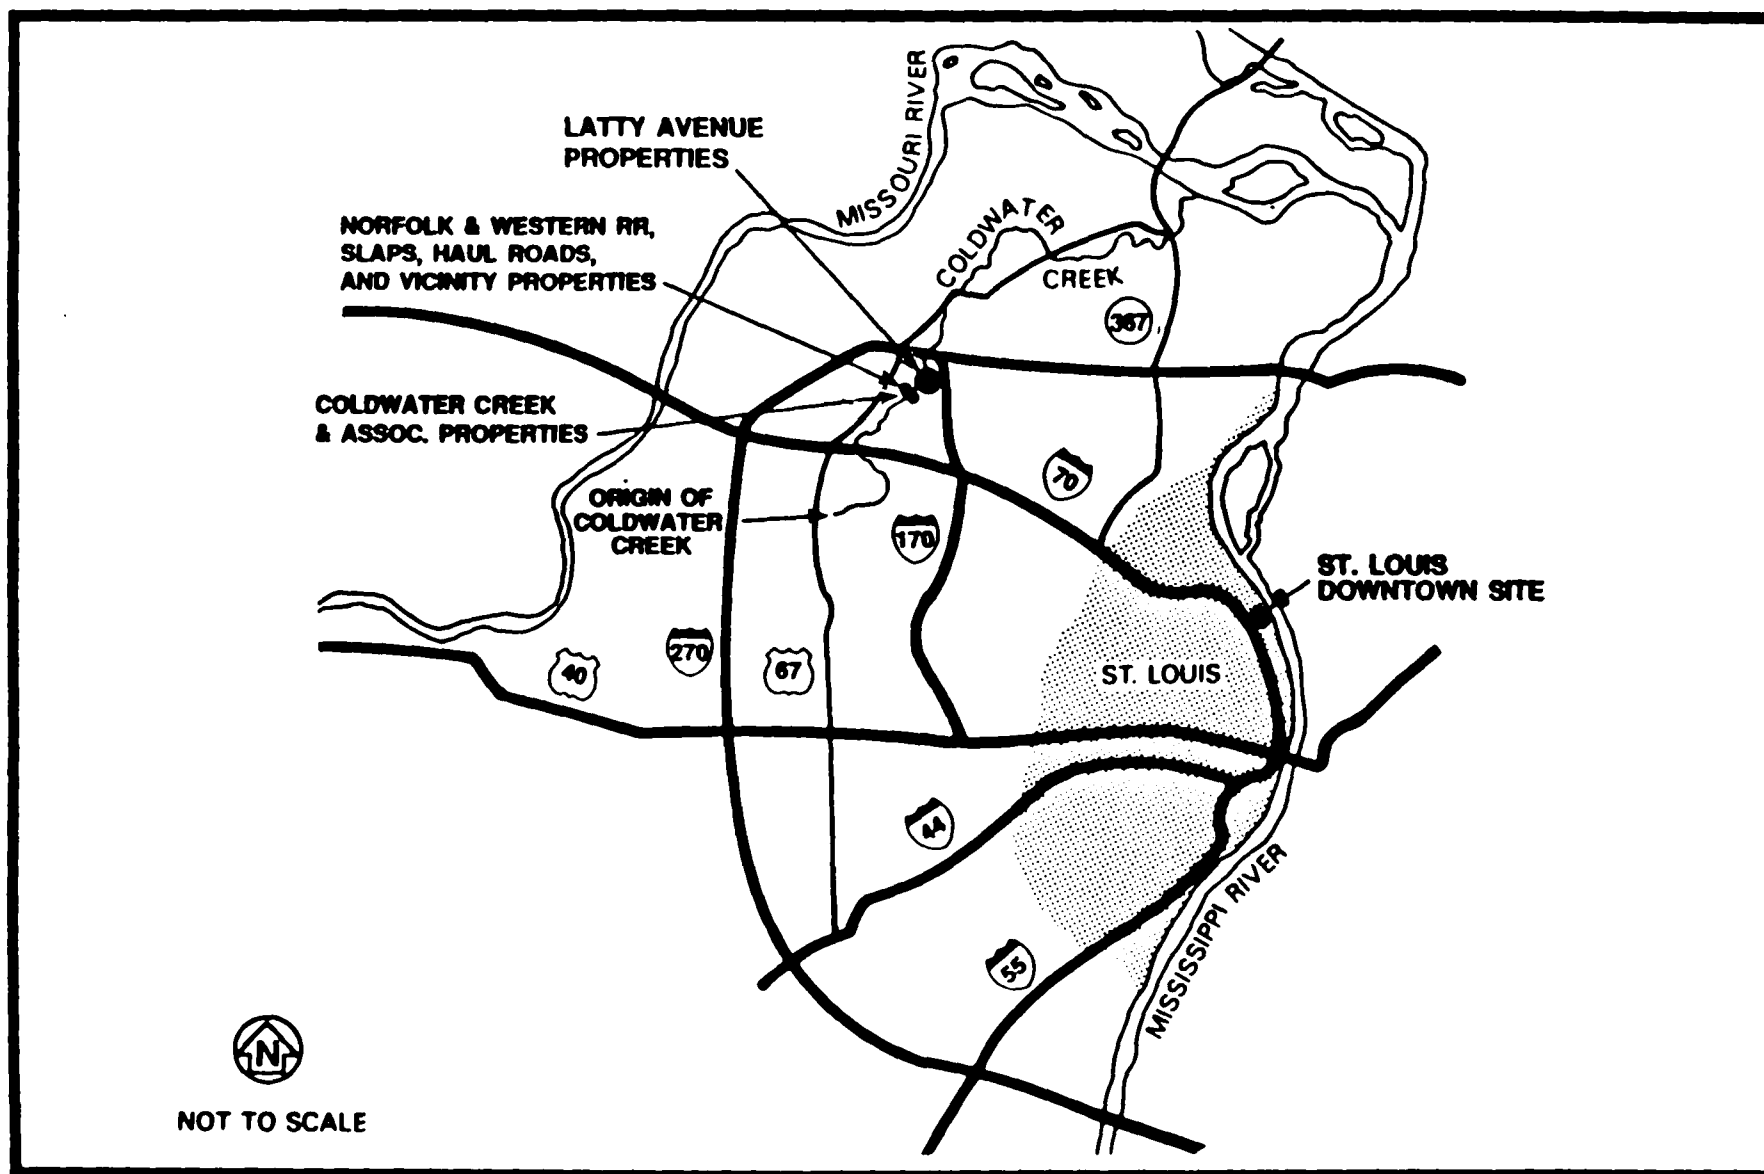
FIGURE 1-1 LOCATIONS OF FUSRAP PROPERTIES IN THE ST. LOUIS, MISSOURI, AREA

This report describes the procedures used to conduct the 1986 through 1989 radiological characterization of FUSRAP properties in the St. Louis, Missouri, area (see Figure 1-1). These properties include

Coldwater Creek, a tributary of the Missouri River, has an overall length of 30.6 km (19 mi). The creek, which originates about 5.8 km (3.6 mi) south of SLAPS at a small spring-fed lake, flows for a distance of 152 m (500 ft) along the west side of SLAPS and discharges into the Missouri River about 22.5 km (14 mi) northeast of the site. Beneath the airport, Coldwater Creek flows in an underground drainage passage. The location of Coldwater Creek is shown in Figure 1-1.

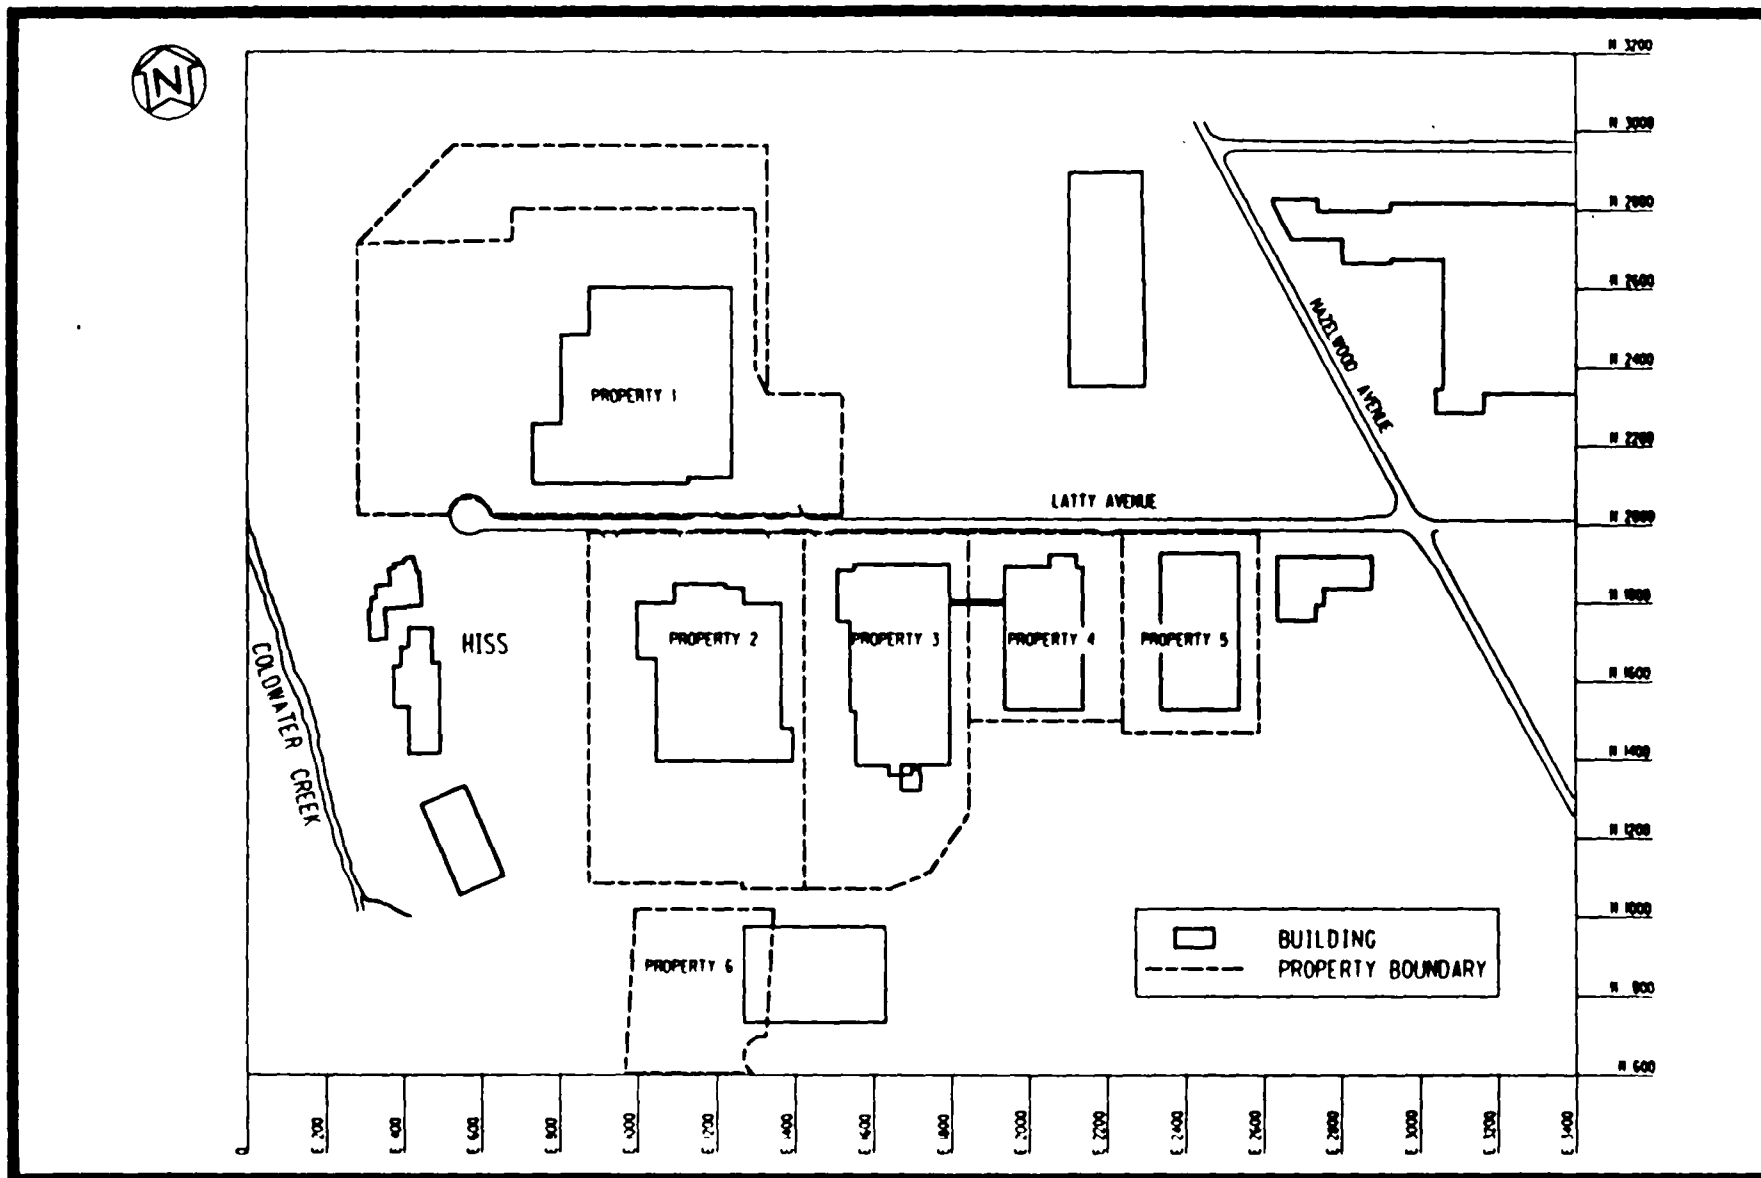
FIGURE 1-3 LOCATIONS OF THE LATTY AVENUE VICINITY PROPERTIES

Each Latty Avenue vicinity property characterized as part of the radiological survey was assigned a numerical identifier that corresponds to a St. Louis County tax map locator number. Table 1-1 references the assigned identifier to its respective tax map locator number. The Latty Avenue vicinity properties lie within the cities of Hazelwood and Berkeley and are shown in Figure 1-3.

This section reports characterization results for six Latty Avenue vicinity properties, whose locations are shown in Figure 1-3. Detailed results for each property are provided in Subsections 3.1 through 3.6. It should be noted that the term "elevated concentrations" of radionuclides refers to concentrations above DOE guidelines.

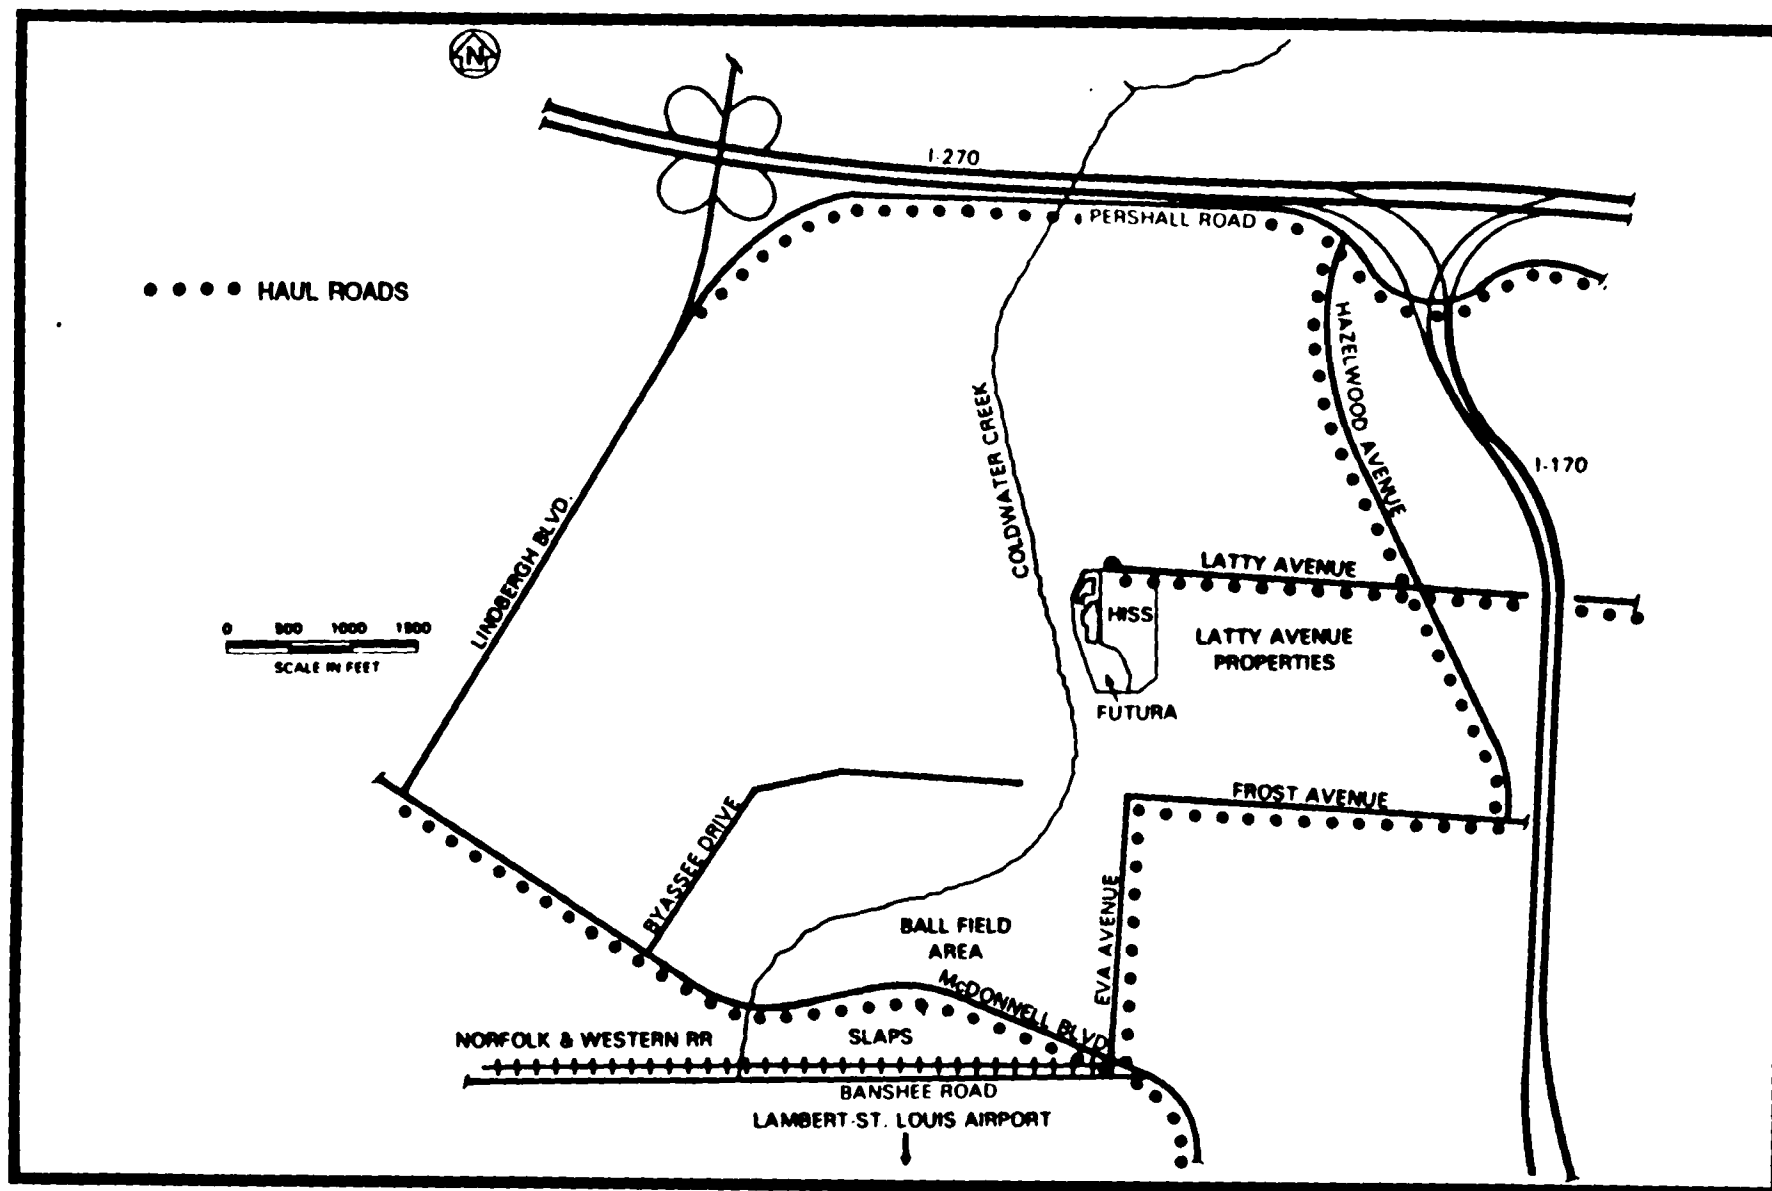
FIGURE 1-4 LOCATIONS OF THE HAUL ROADS SURVEYED BY BNI FOR DOE

The haul roads, believed to have been used during waste transfer among the St. Louis properties, include Latty Avenue, McDonnell Boulevard, Hazelwood Avenue, Pershall Road, Eva Avenue, and Frost Avenue. Characterization results from the right-of-way of these roads are reported with those of the appropriate associated vicinity properties. These routes traverse Hazelwood, Berkeley, and St. Louis and are located near HISS and SLAPS as shown in Figure 1-4.

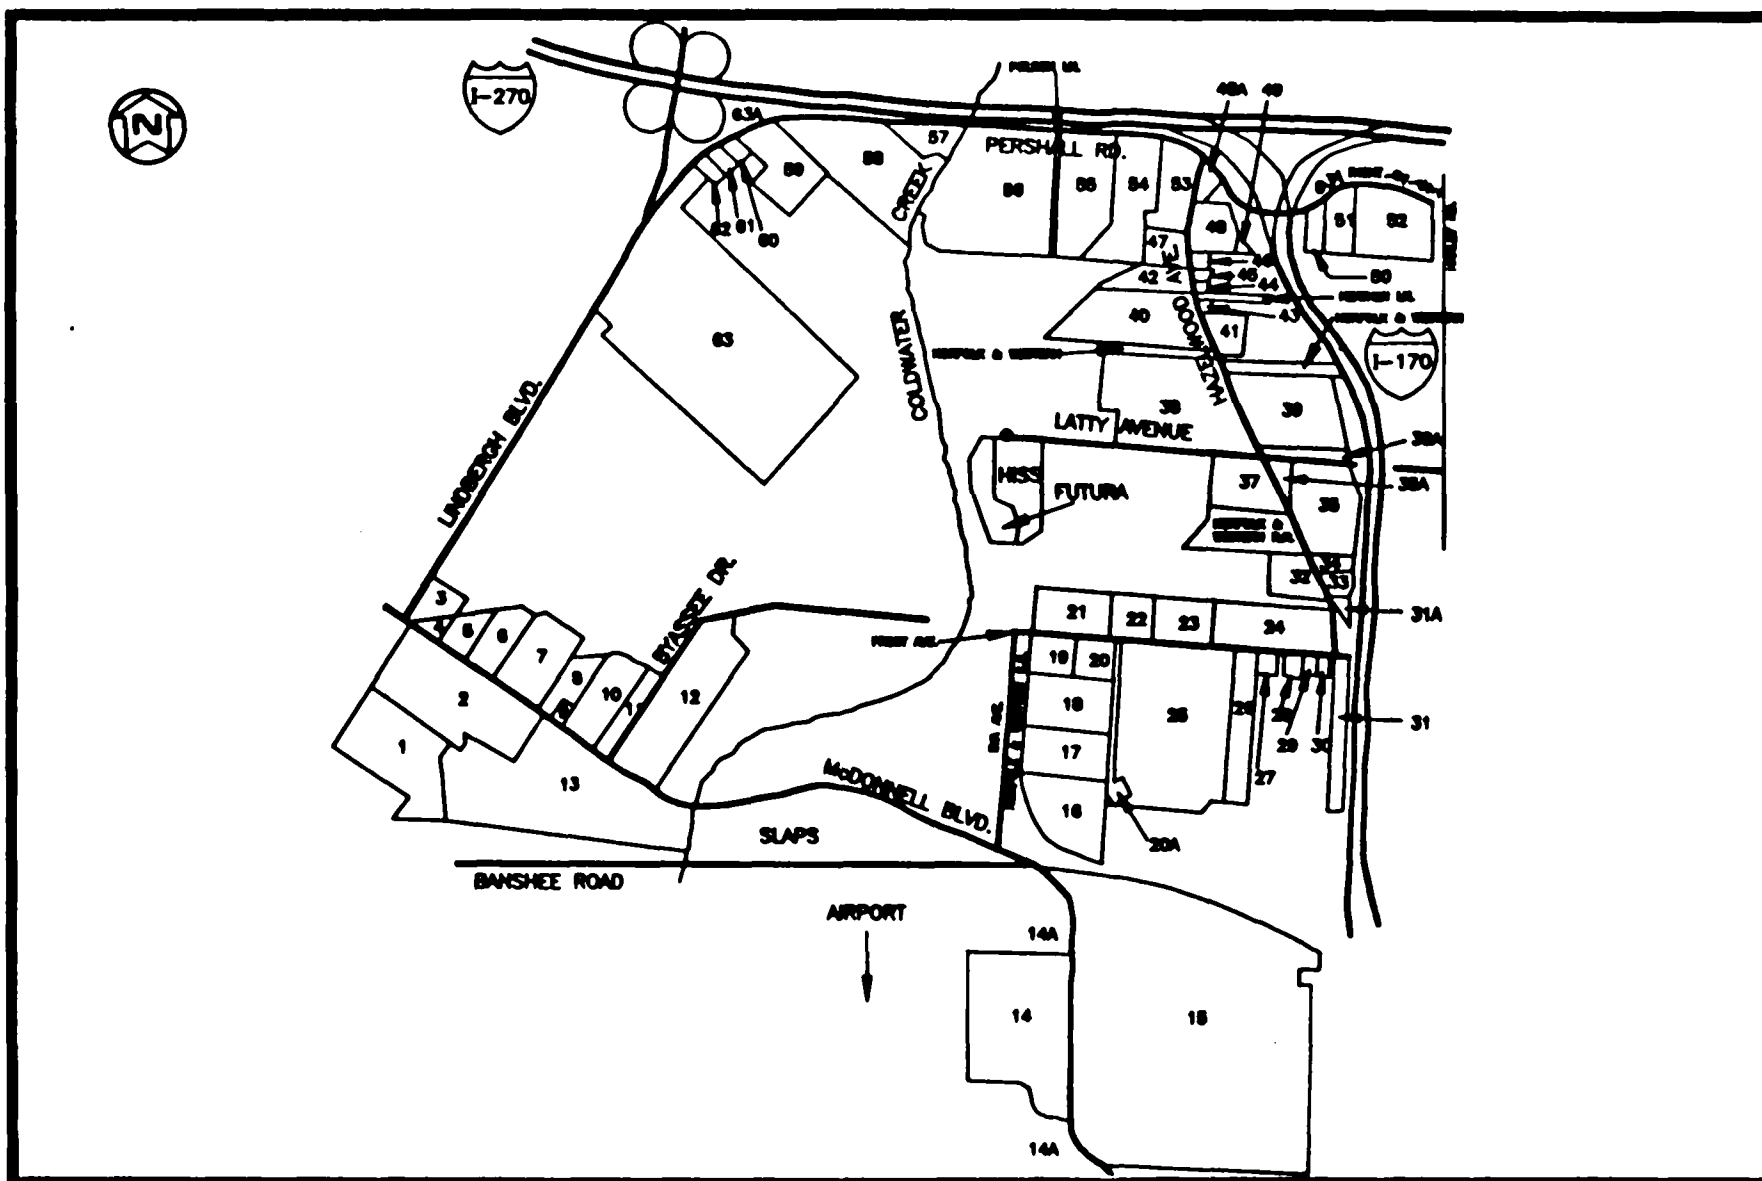
FIGURE 1-5 LOCATIONS OF THE HAUL ROADS VICINITY PROPERTIES

In addition to these haul roads, several adjacent properties were included as part of the radiological characterization (see Figure 1-5). Each haul road vicinity property characterized as part of the radiological survey was assigned a numerical identifier that corresponds to a St. Louis County tax map locator number. Table 1-2 references the assigned identifier to its respective tax map locator number.

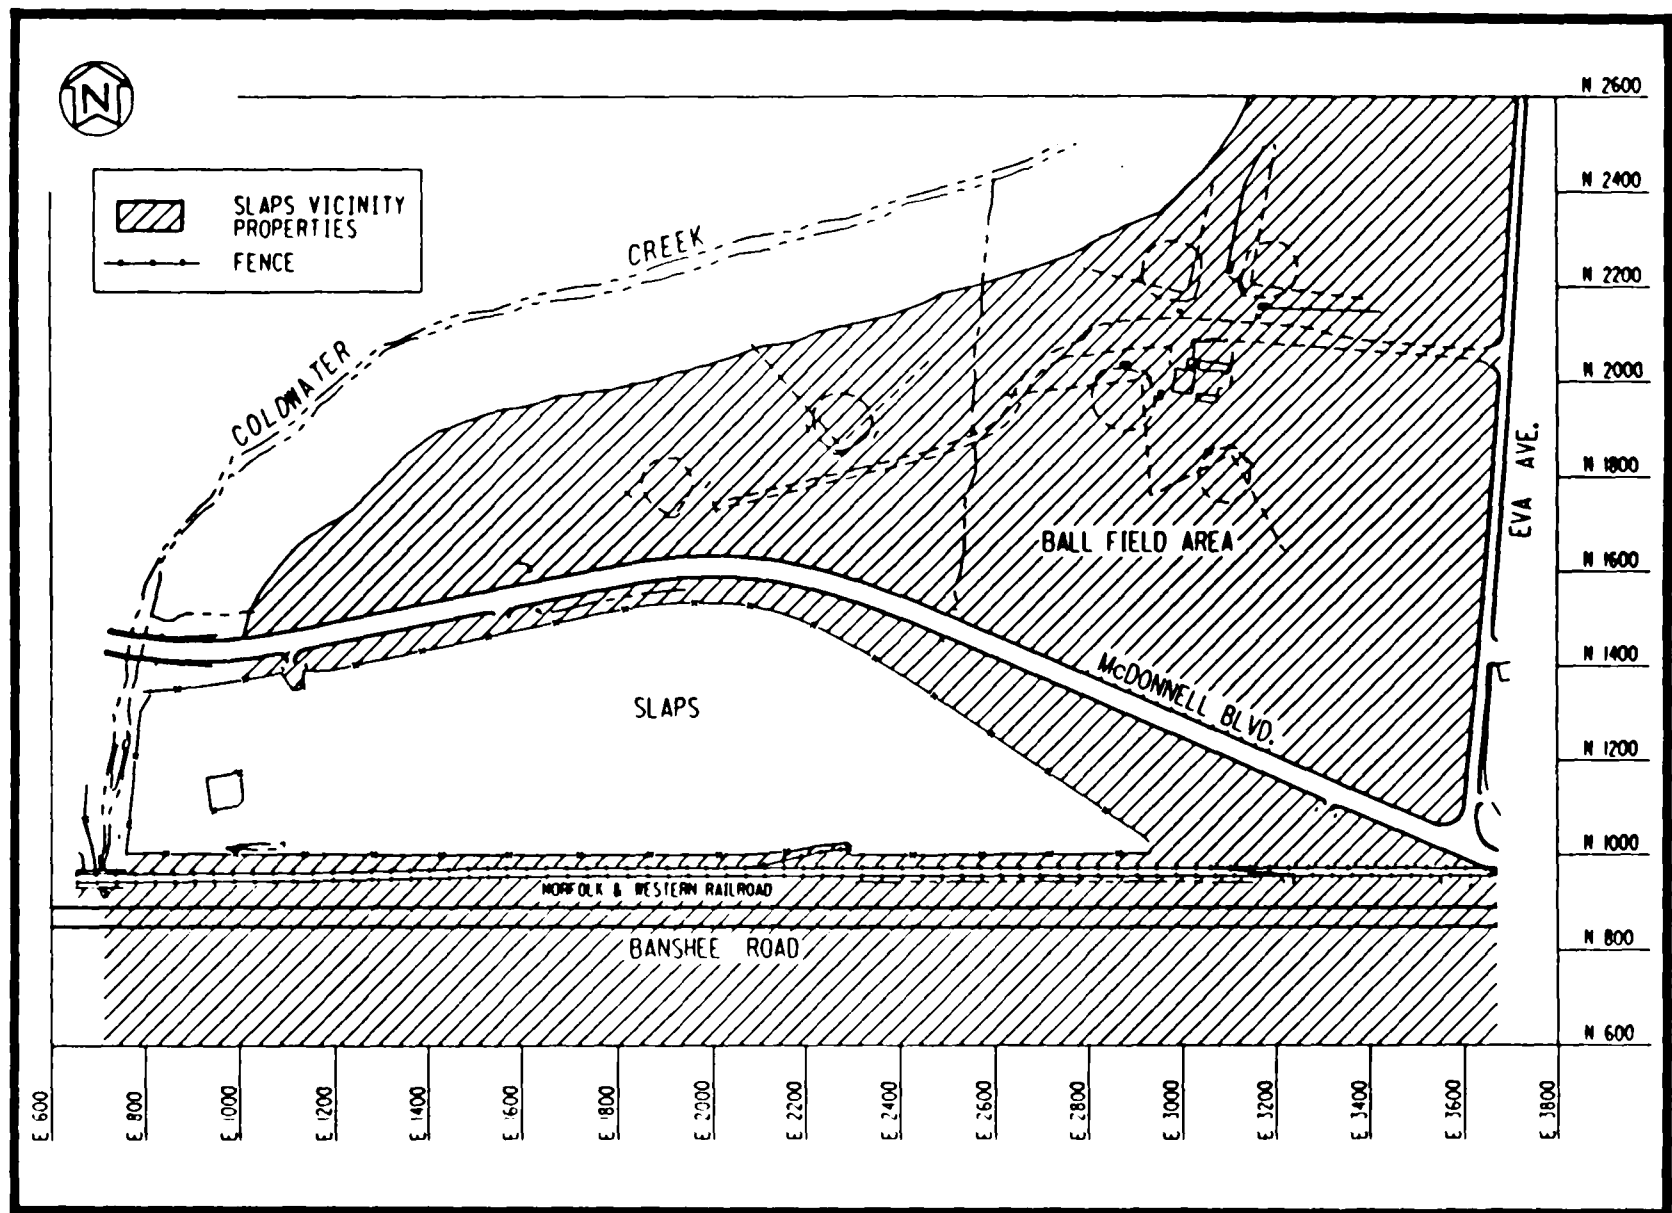
FIGURE 1-6 LOCATIONS OF THE SLAPS VICINITY PROPERTIES

The SLAPS vicinity properties include Banshee Road, the area south of Banshee Road owned by the St. Louis Airport Authority, the recreational areas to the north of SLAPS known as the ball field area, and the ditches to the north and south of SLAPS. Figure 1-6 shows the locations of the SLAPS vicinity properties.

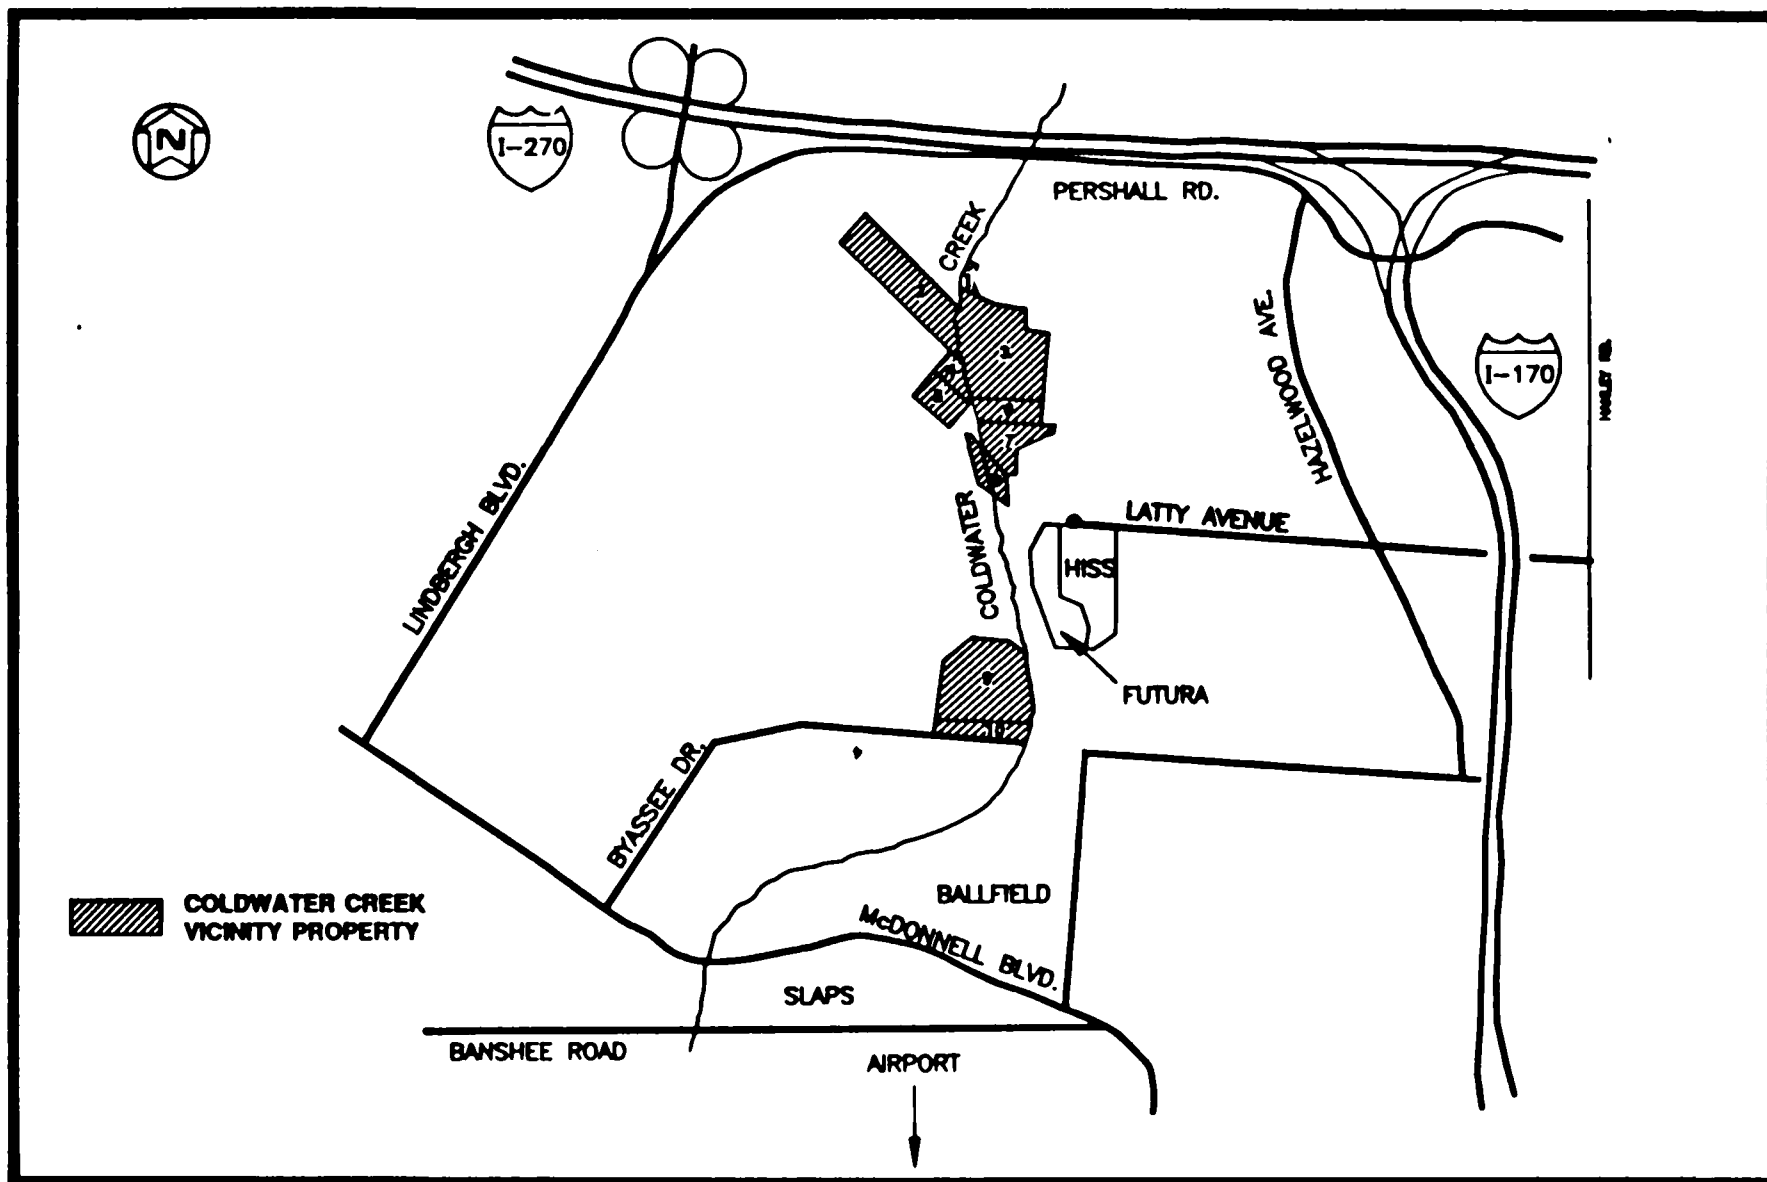
FIGURE 1-7 LOCATIONS OF THE COLDWATER CREEK VICINITY PROPERTIES

Each vicinity property associated with Coldwater Creek was assigned a numerical identifier that corresponds to a St. Louis County tax map locator number. Table 1-3 references the assigned identifier to its respective tax map locator number. Figure 1-7 shows the vicinity properties associated with Coldwater Creek.

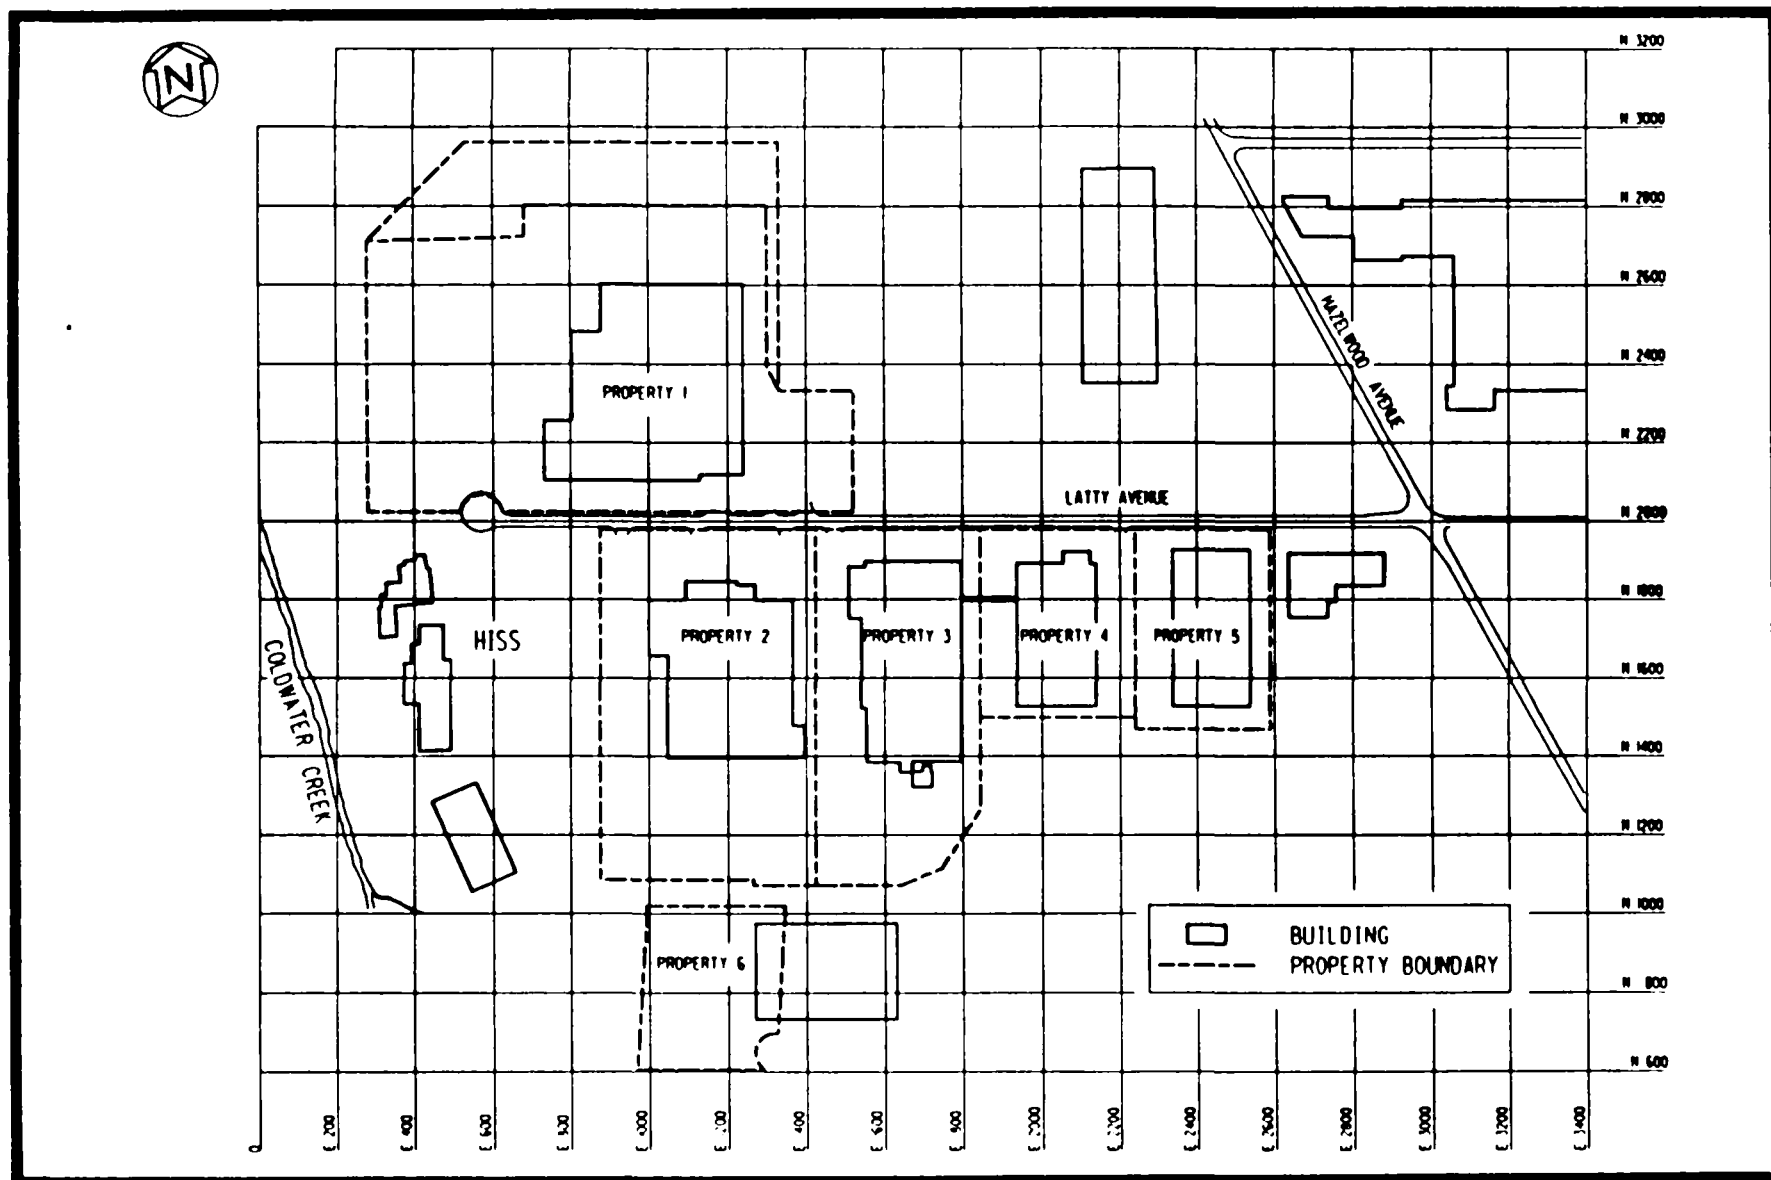
FIGURE 2-1 SURVEY GRID FOR THE VICINITY PROPERTIES ADJACENT TO LATTY AVENUE

A civil surveyor established a 15-m (50-ft) grid on the vicinity properties adjacent to Latty Avenue by marking the intersections of a series of perpendicular lines, as shown in Figure 2-1. [Figure 2-1 is marked at 61-m (200-ft) intervals because of the size of the drawing.] The grid origin used during the remedial action conducted in 1984 along the Latty Avenue right-of-way was reestablished.

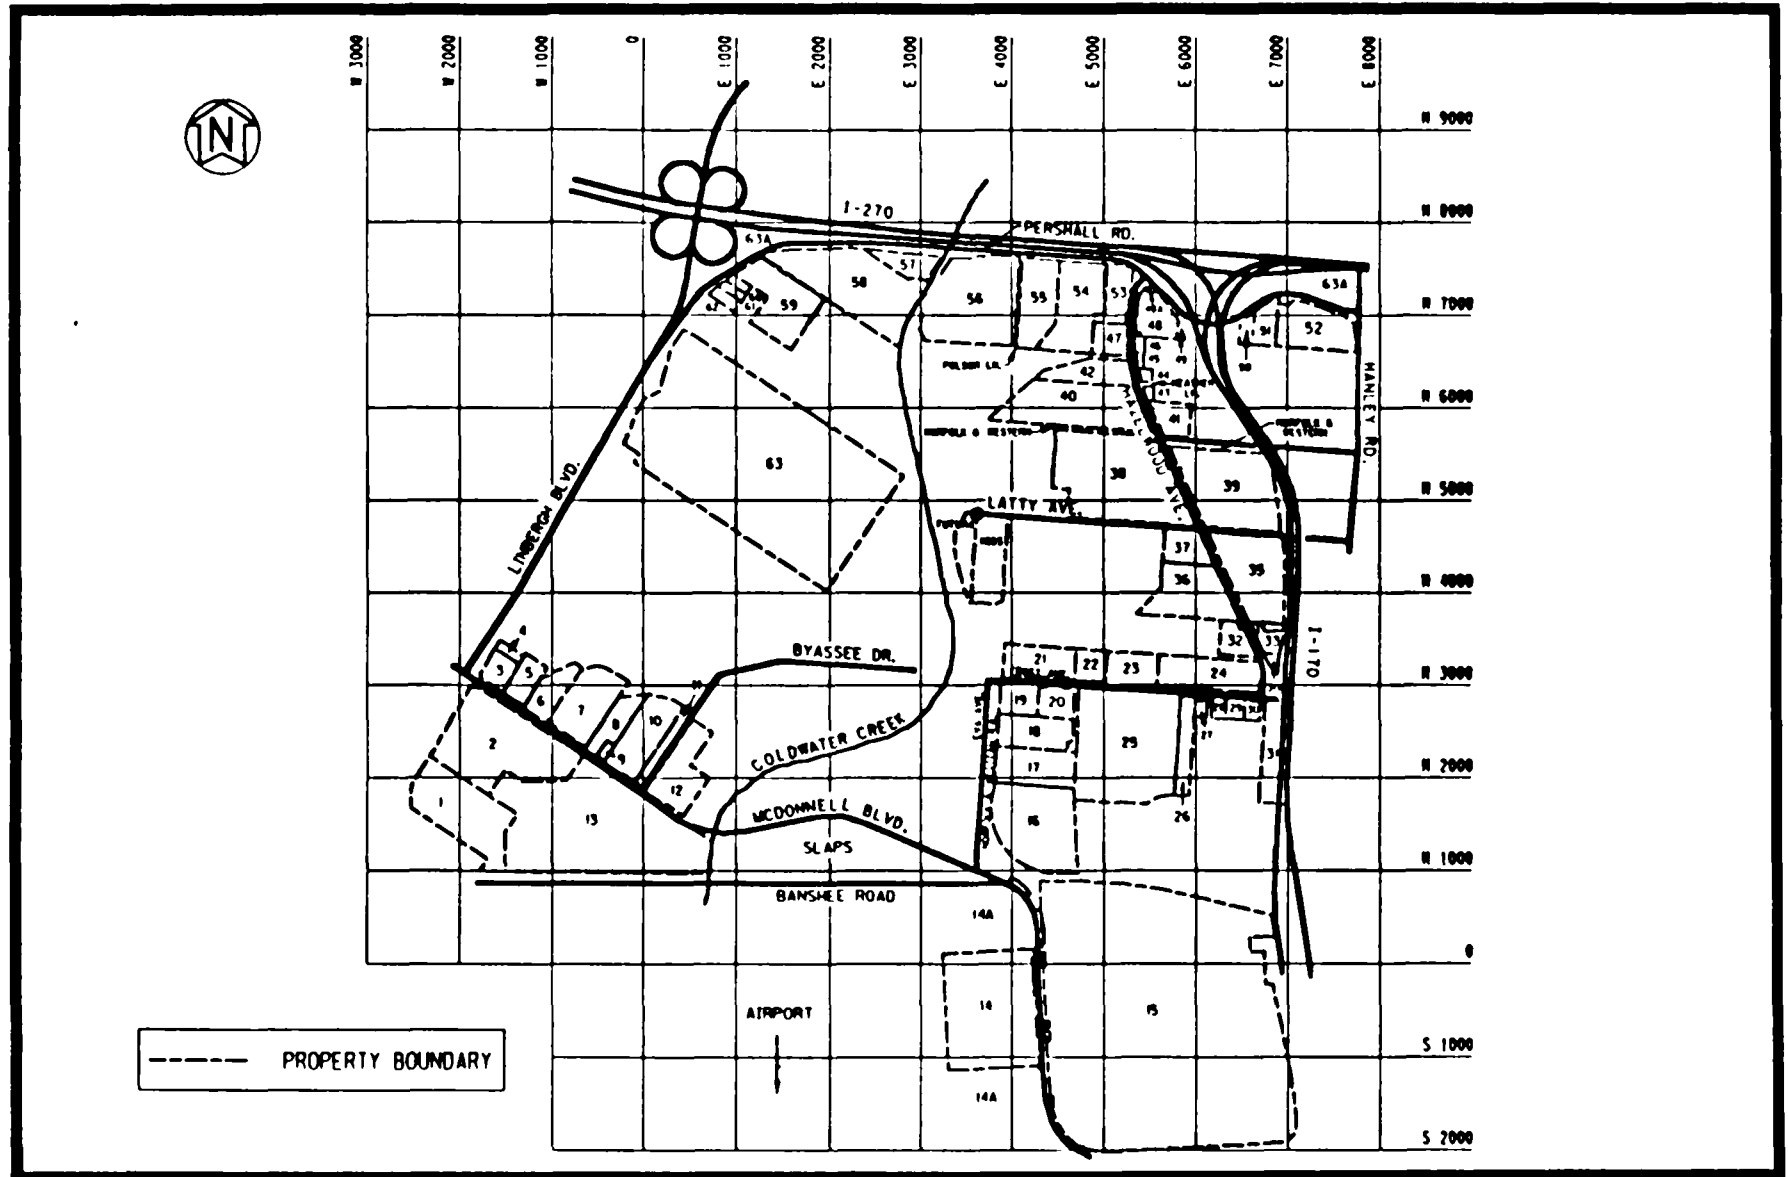
FIGURE 2-2 SURVEY GRID FOR THE HAUL ROADS AND ASSOCIATED VICINITY PROPERTIES

A 15-m (50-ft) grid was also established over the haul roads and adjacent properties, extending approximately 46-m (150 ft) from the roadways (see Figure 2-2). [Figure 2-2 is marked at 305-m (1,000-ft) intervals because of the size of the drawing.] A 15-m (50-ft) grid was established over the SLAPS vicinity properties as shown in Figure 2-3. [Figure 2-3 is marked at 61-m (200-ft) intervals because of the size of the drawing.] The grid origin was the southwest corner of SLAPS. These grids were tied to the SLAPS grid system and to the Missouri state grid system with sufficient detail to allow for reestablishment at a later date. When characterization work was initially performed at 9200 Latty Avenue and SLAPS, each site was treated independently and a grid was established at each. At that time, it was not suspected that contamination would be as extensive as it is in the area and that the two sites would be essentially continuous. This accounts for having different grid systems for the two sites.

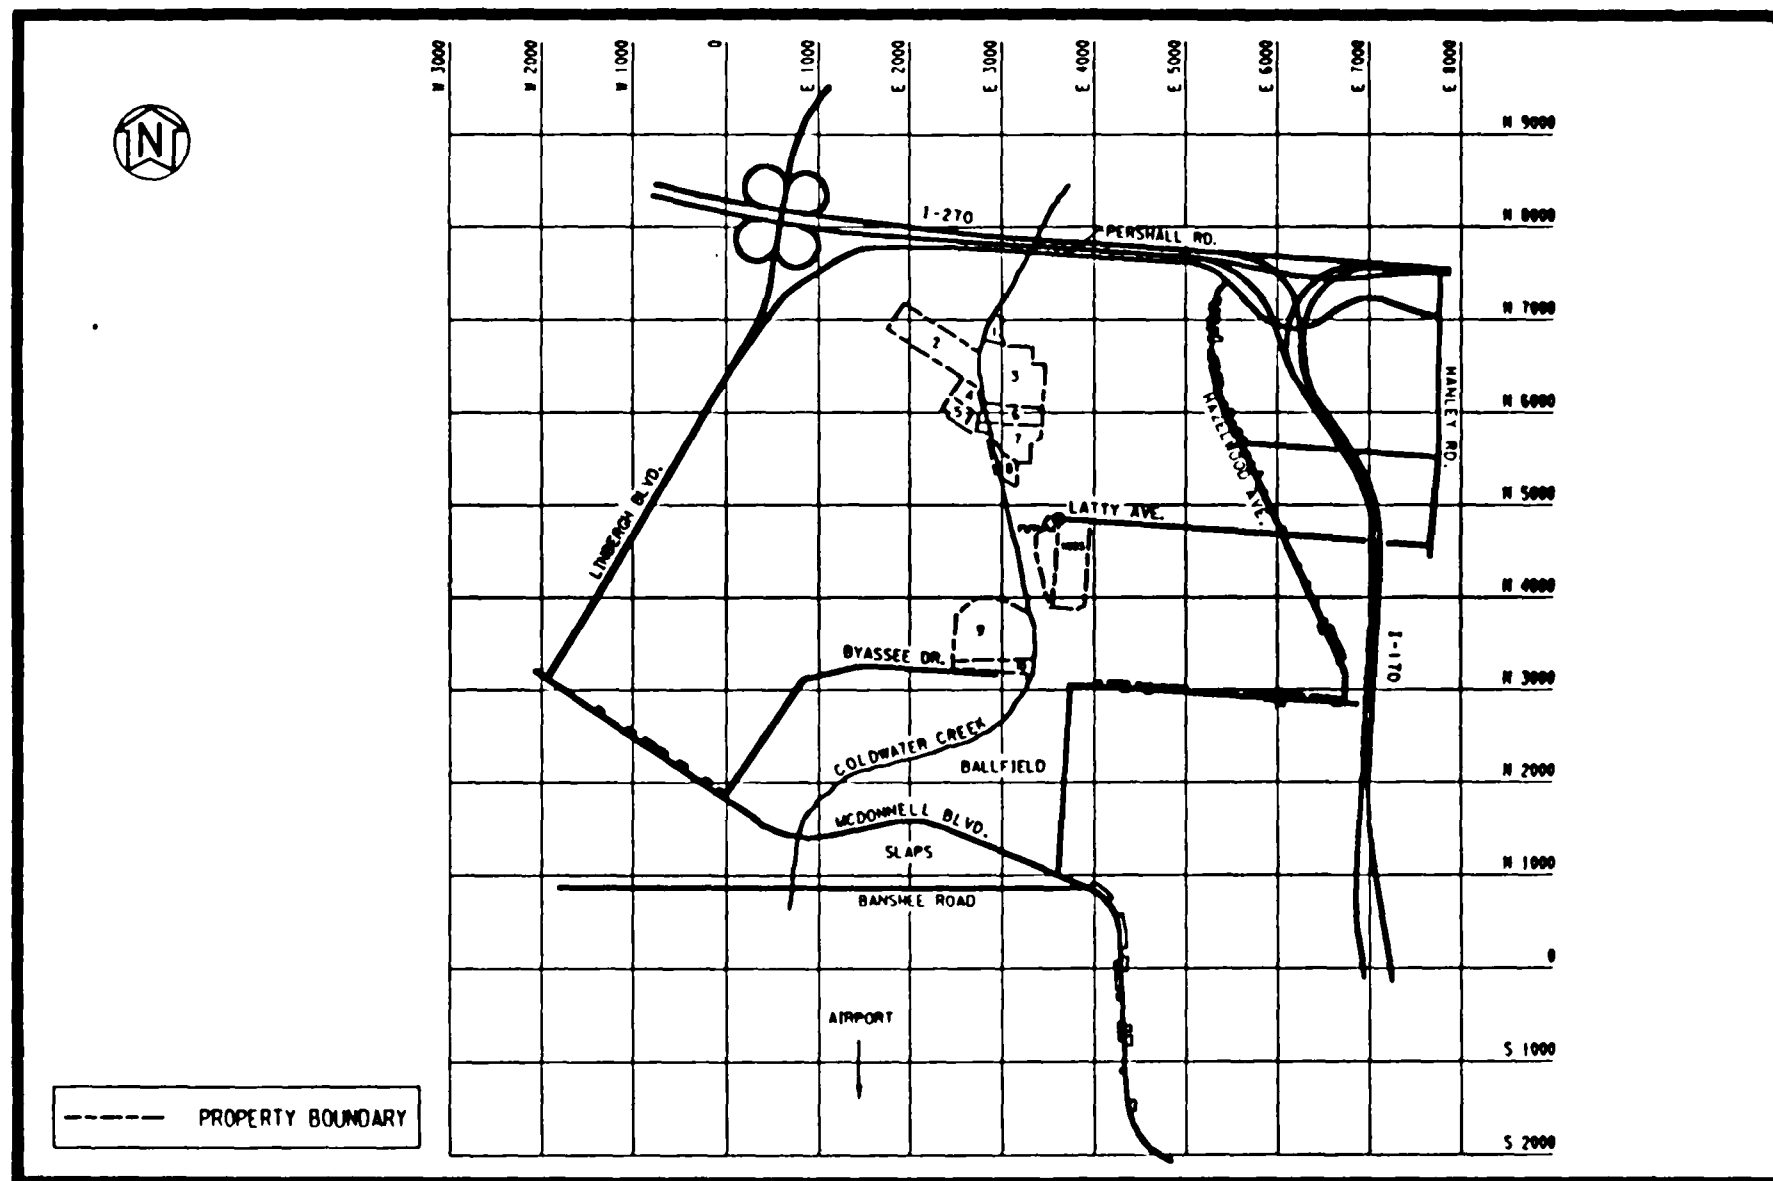
FIGURE 2-4 SURVEY GRID FOR COLDWATER CREEK

Minimal clearing was done along Coldwater Creek so that a traverse line could be established with right angle offsets at 152-m (500-ft) intervals (Figure 2-4). The traverse line was referenced back to the SLAPS grid. Sampling locations were determined by measuring along the offset lines. All characterization data correspond to coordinates on the grids. All grids shown in the figures in this document are displayed in measurement units of feet.

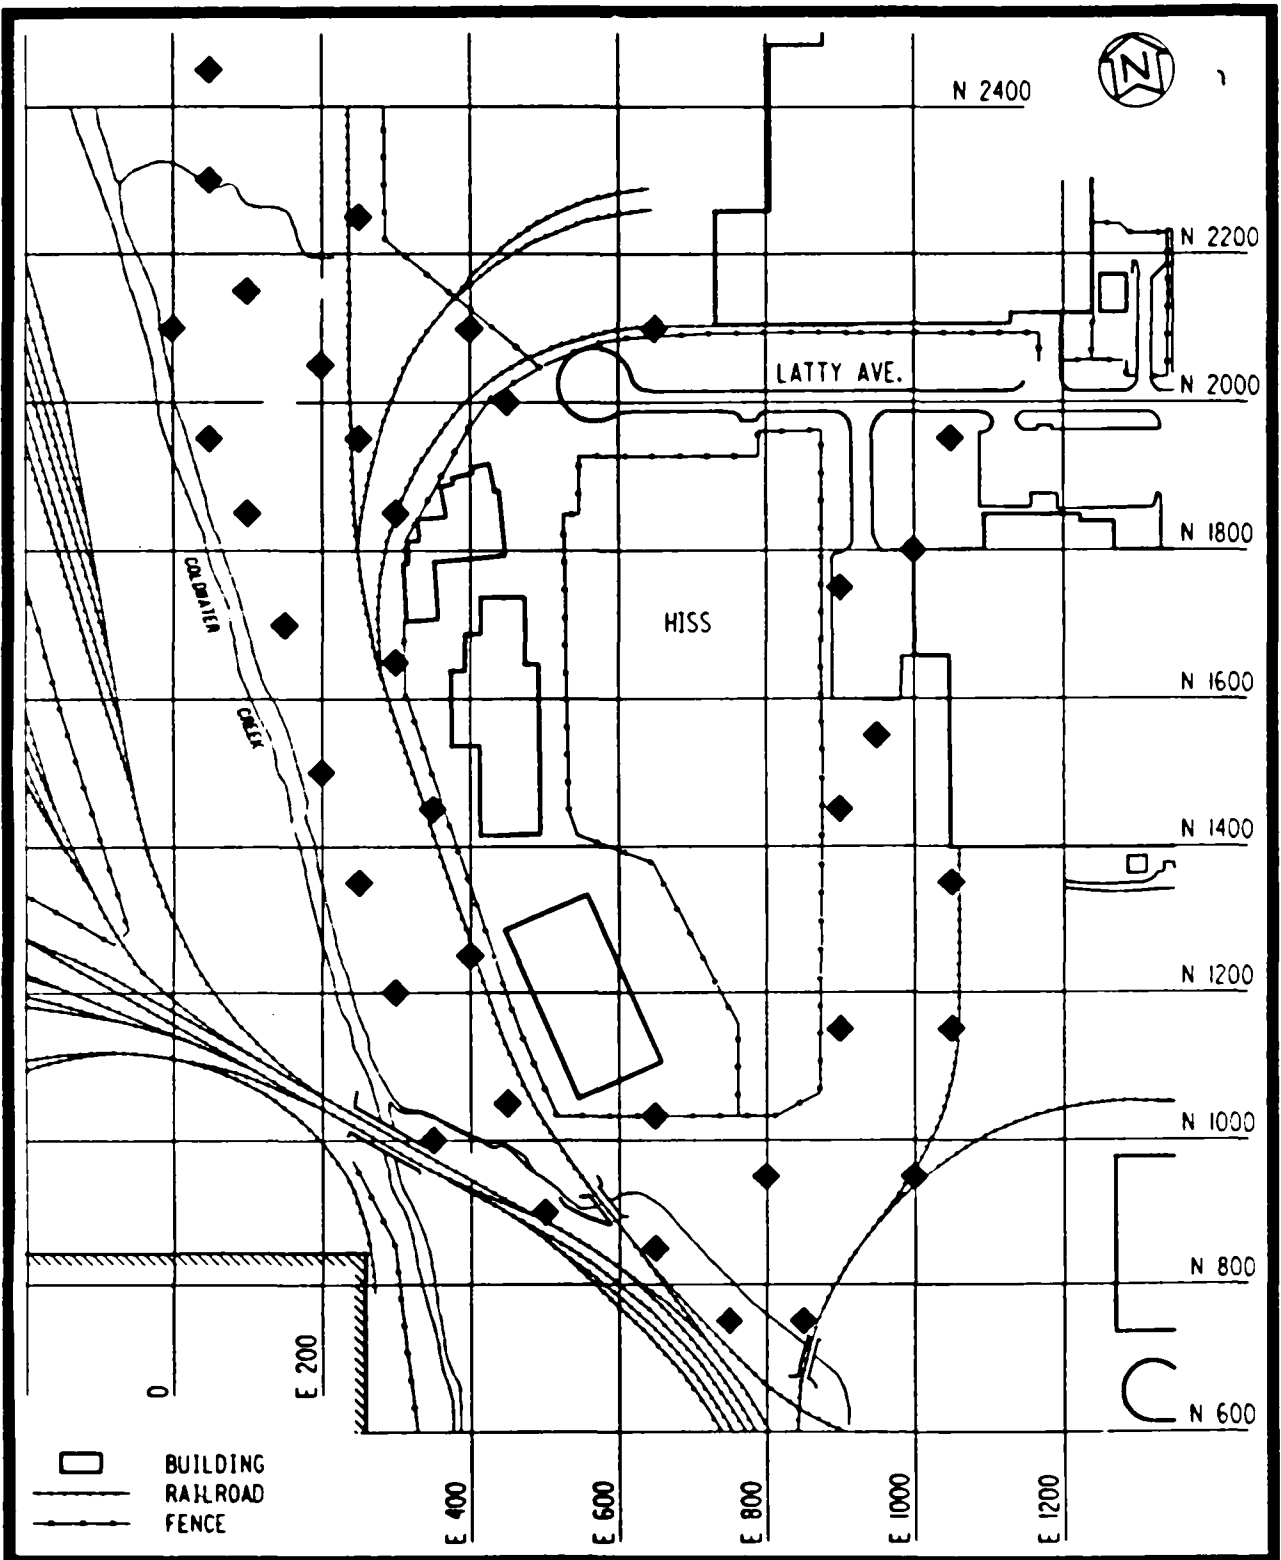
FIGURE 2-5 GAMMA EXPOSURE RATE MEASUREMENT LOCATIONS AT THE NORFOLK AND WESTERN RAILROAD PROPERTY ADJACENT TO HISS

Gamma exposure rates at 1 m (3 ft) above the ground were measured on the Norfolk and Western Railroad property adjacent to HISS and on the SLAPS vicinity properties to the north and south of SLAPS using a pressurized ionization chamber (PIC). The PIC has a response to gamma radiation that is proportional to exposure in roentgens. Readings were made at 37 selected grid points on the Norfolk and Western Railroad property adjacent to HISS (see Figure 2-5) and at 69 locations at SLAPS and vicinity properties (see Figure 2-6). This exposure rate information will be valuable for use in remedial action planning, environmental monitoring, and the preparation of documentation required by CERCLA/National Environmental Policy Act (NEPA) activities.
